# Canon DM-100 microphone rattle noise fix

How to fix the Canon DM-100 video microphone rattle noise. For Canon Vixia / Legria cameras in the HF-series.

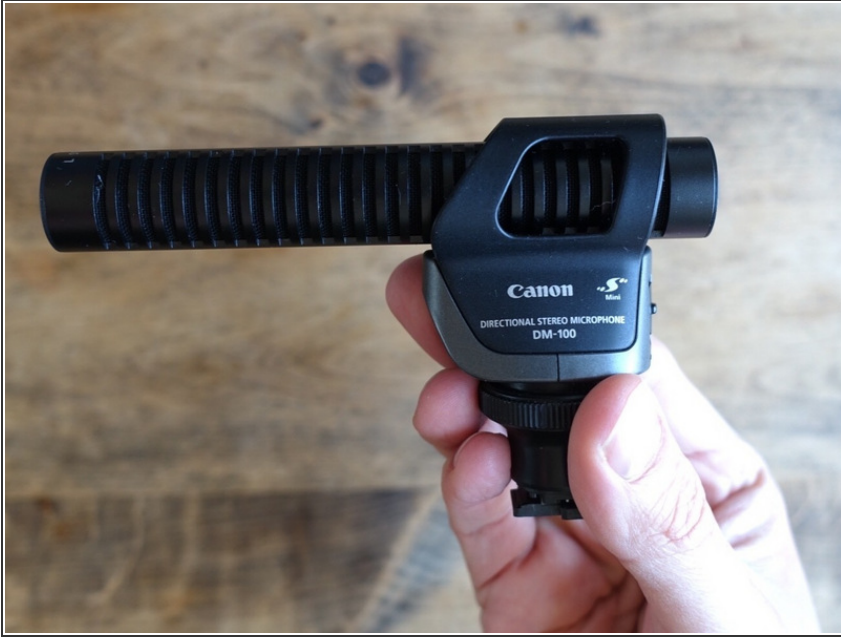
## Step 1 — The Mic

- This is the rattly beast.

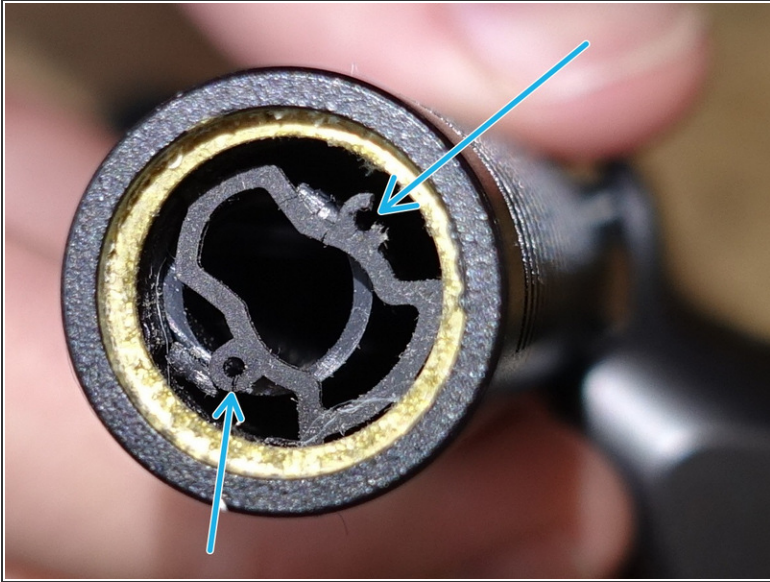
### Step 3 — The culprit

- Canon has used an elastic band for vibration reduction of the directional "sound pipe" (seen as a circle behind the elastic band).
- The pipe visible behind the elastic is supposed to be mounted to the inner wall with the two marked circular joints.
- These incredibly weak joints are bound to break as the rubber loses its elasticity.

The DM-100 is a good, but expensive microphone for all Canon camcorders. The internal suspension is broken by design, and will render the microphone unusable after 2-3 years of use.

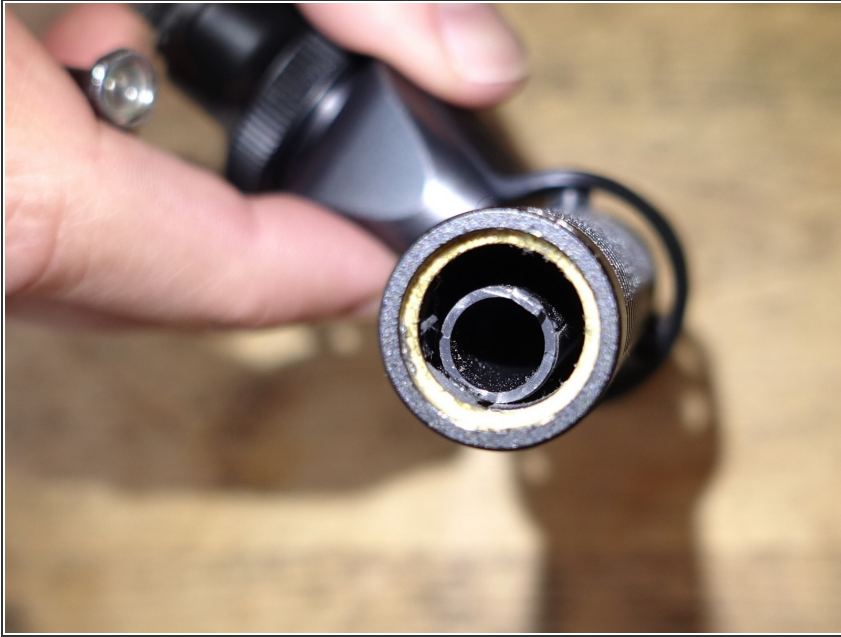
## Step 5 — Clean slate

- The culprit of the rattling noise is now apparent. A plastic cylinder stretches through the whole of the microphone, enabling the microphones forward focused / directional sound.
- When the rubber band breaks because of the bad joints, this thing hits the inner side of the cylinder.

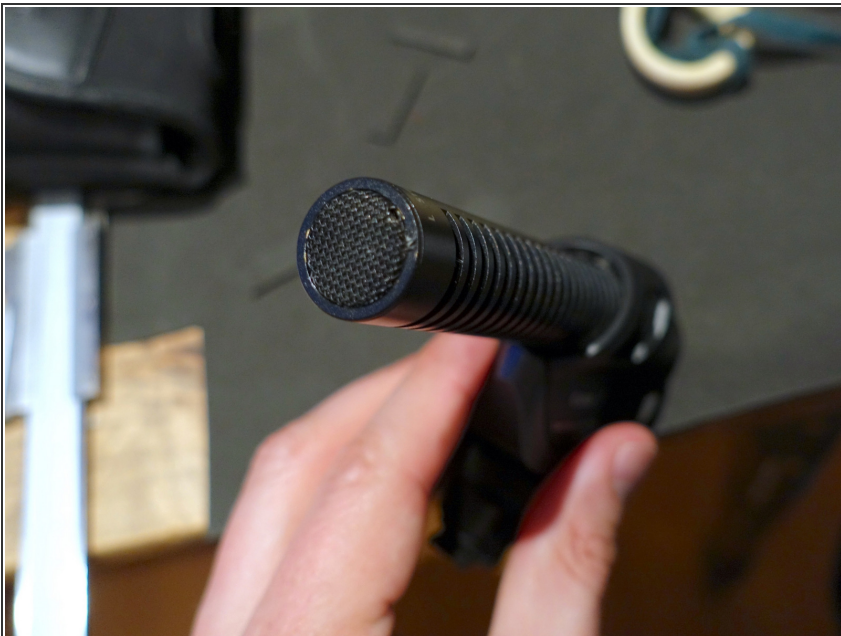
## Step 10 — Done

- There! 190\$ microphone fixed for less than a dollar.
- The audio quality isn't affected at all.

This fix is a permanent fix to Canons poor design. Since the pipe is solid, and the foam is only reaching about 2cm into the pipe, audio quality is not affected at all.
